MARINE INVESTIGATION REPORT
M01W0006

FATAL ACCIDENT

CONTAINER SHIP *ALLIGATOR VICTORY*
DELTAPORT, VANCOUVER, BRITISH COLUMBIA
09 JANUARY 2001

Report Number M01W0006

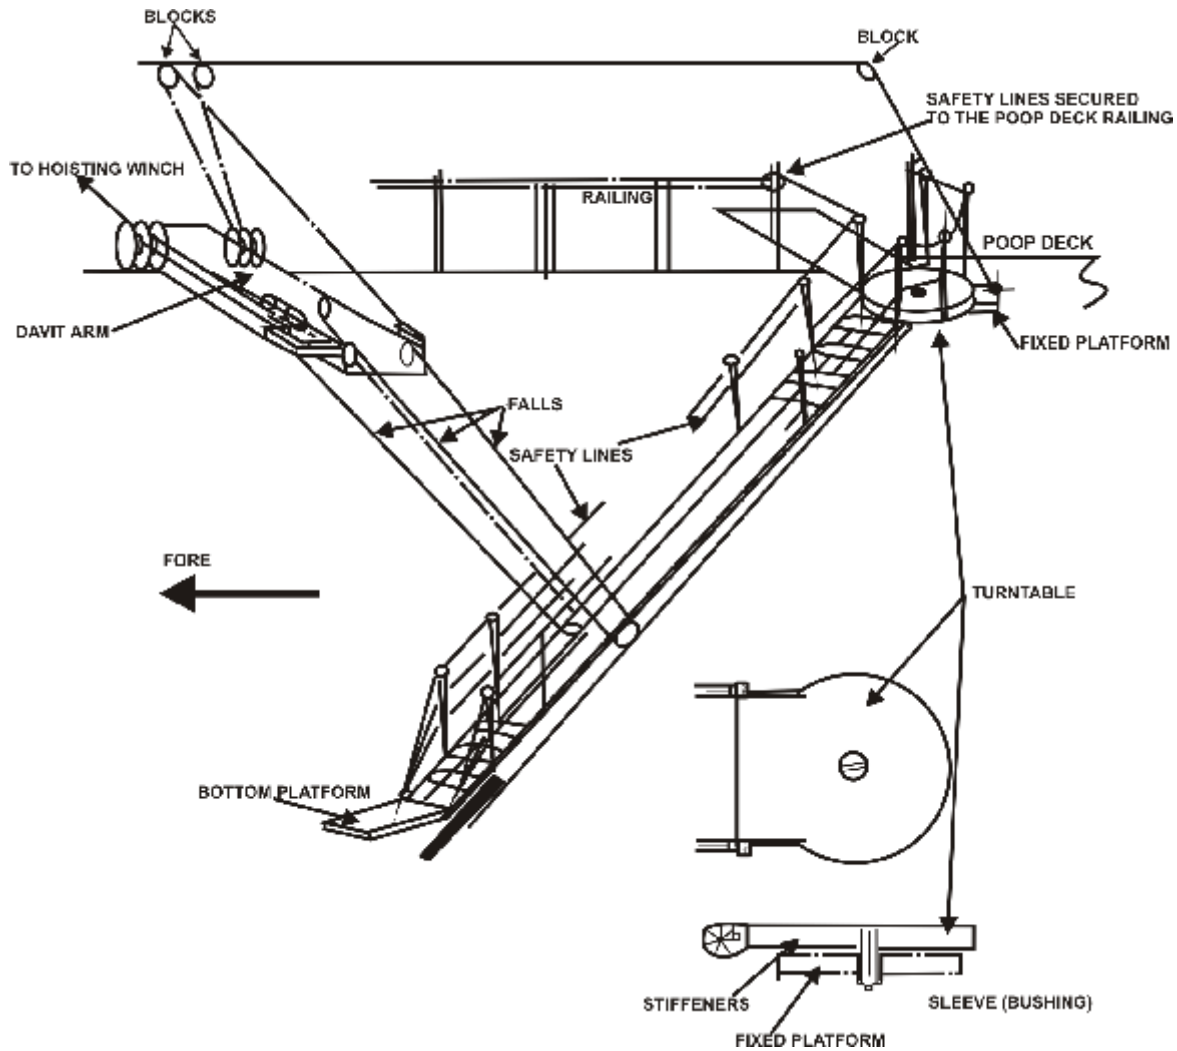
Figure 1. Typical arrangement of an accommodation ladder, its falls, and its winch.
N.B.: Actual arrangement will vary from vessel to vessel. See Figure 2 for the location of the snatch block and figures 3 and 4 for that of the broken pad eye.
